**Project:** Jetting resistance test according to draft  
DIN-standard 19523, August 2007

**Product:** Quick-Lock-System

**Jetting resistance test**  
**according to**  
**Draft DIN-standard 19523, August 2007**

**Report**

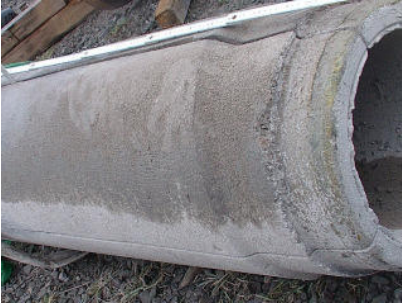
Damage description	Vitrified clay pipe	Concrete pipe
1	Fragments

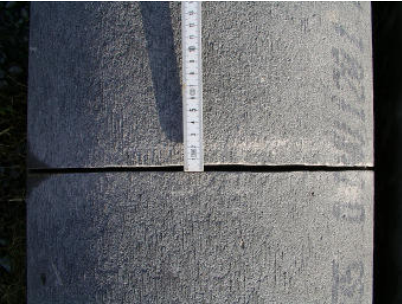
2	Cross-crack	Not taken in consideration

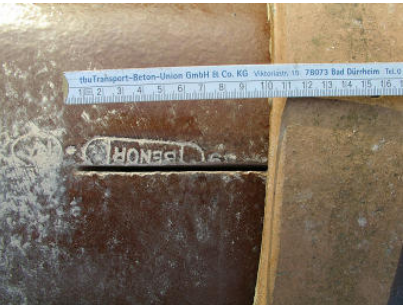
3	Longitudinal crack

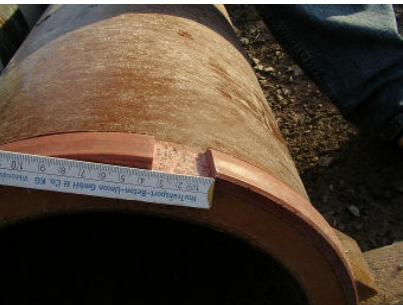
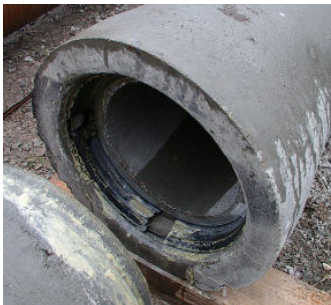
Not taken in consideration
4	Broken sealing in joint section

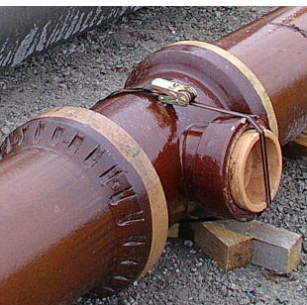
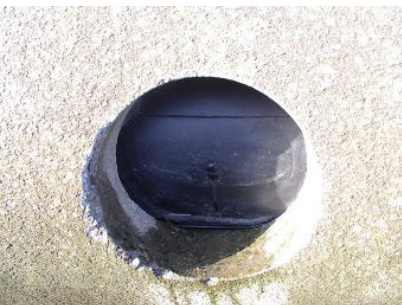
5	Lost piece / failed connection

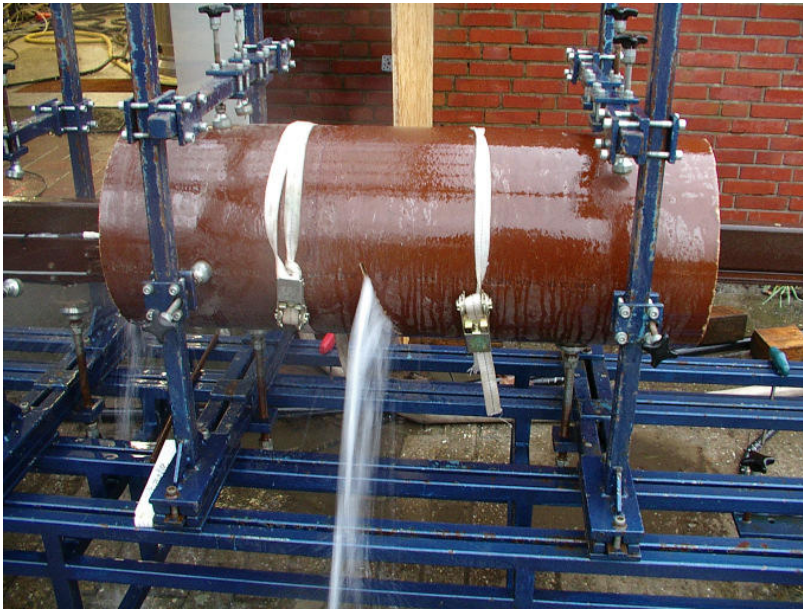
**Fig. 5:** test specimen with placed gasket installed in test-stand

During the material test the water jet forced through the sealing and came out of the pre-damaged pipe-wall (fig. 5).

After the test there were no visual damages on the gasket. Beyond it the water tightness of the system was proved according to the air test method described in DIN EN –standard 1610 [2].

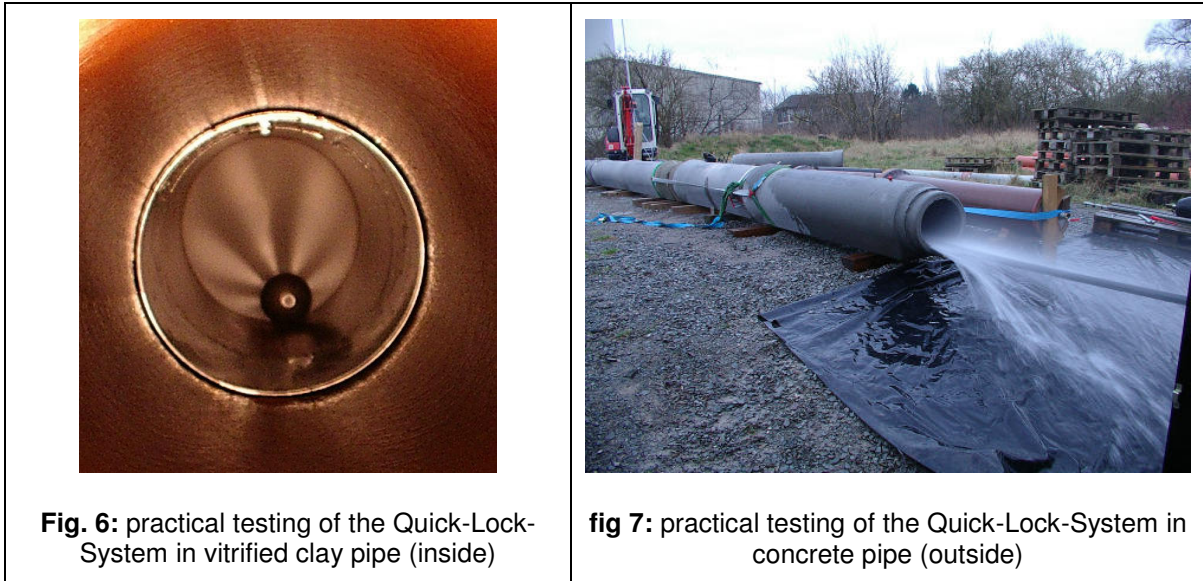
During the material test the area around the cross-crack at the concrete pipe was conspicuous. In the development of the test an increasing amount of water established which came out of the pre-damaged pipe-wall.

After the test there were visual deformations on two of the gasket-edges placed in the vitrified clay pipes. The cause of these deformations is obviously a mechanical hitch of the nozzle during the retreat-process. During the water tightness-test with 0,5 bar according DIN EN –standard 1610 [2] one of the gaskets which was placed at the cross-cracked concrete-pipe failed.

After replacing the gasket which failed the jetting test was repeated in this section of the test-course with the following proofs of failures.

The repeated investigations on the gasket system had shown no further failures.

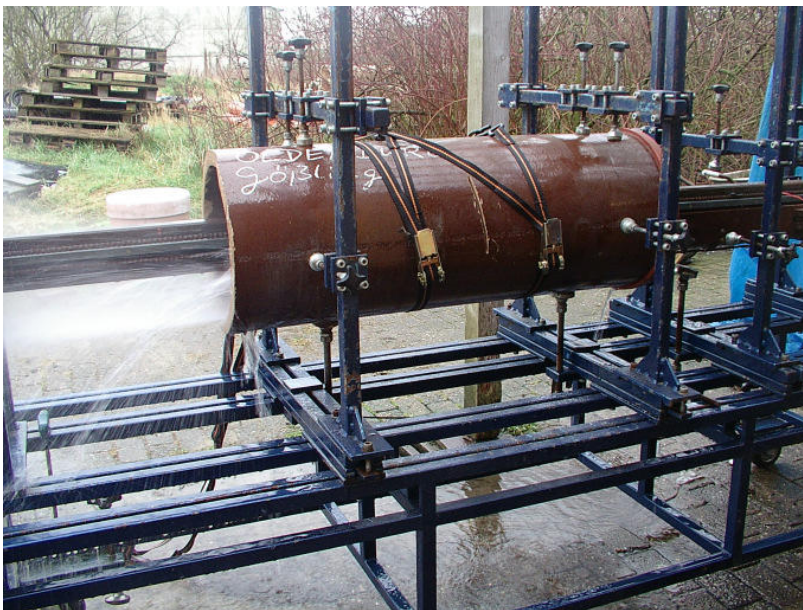
**Fig. 8:** test assembly with beaded gasket installed in test-stand

Compared to the test-results of the „standard“-gasket the beaded gasket prevented the forcing of the water jet through the sealing. During the test the gasket obviously stayed tight.

After the test there were no visual damages on the gasket. Beyond it the water tightness of the system was proved according to the air test method described in DIN EN –standard 1610 [2].
