**ASSESSMENT OF THE UHRIG KANALTECHNIK  
QUICK LOCK LOCAL REPAIR SYSTEM**

**WRc Ref: UC7982  
June 2009**

Report: UC7982  
Date: June 2009  
Authors: K Adams and A T Russell  
Contract Manager: A T Russell  
Contract No.: 15042-0

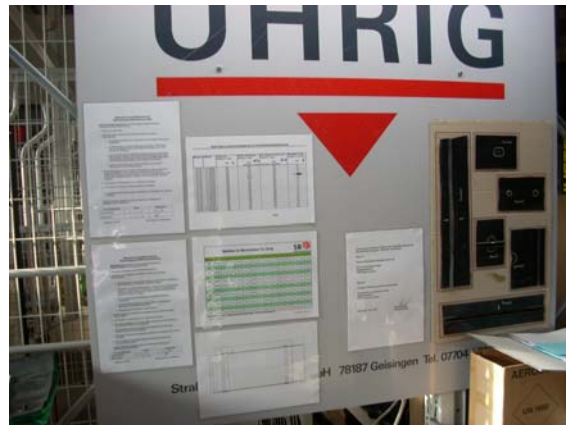
It was noted that a schematic with the tolerance was on display at the work station in the finished good store. The work station also contained a display of cut outs for rejected seals as an aid to what is not acceptable.

**Figure 5.1 Work station with table of tolerance requirement and examples of gaskets defects**

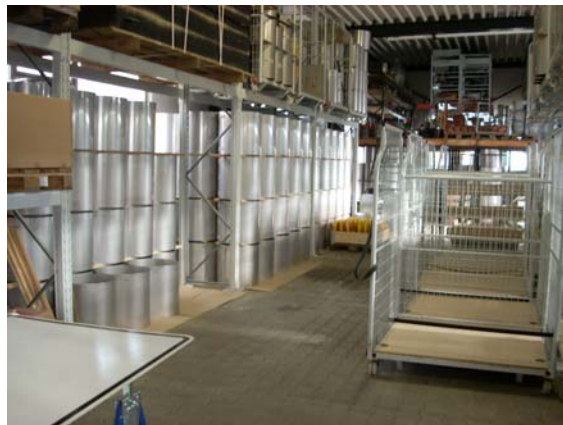
- The storage area was tidy, laid out in an orderly manner with allotted storage space for each component, based on diameter of the gasket or steel sleeve, to enable items to be easily located.
- All goods were clearly labelled.

**Figure 5.2** Finished goods storage at Uhrig Kanaltechnik GmbH

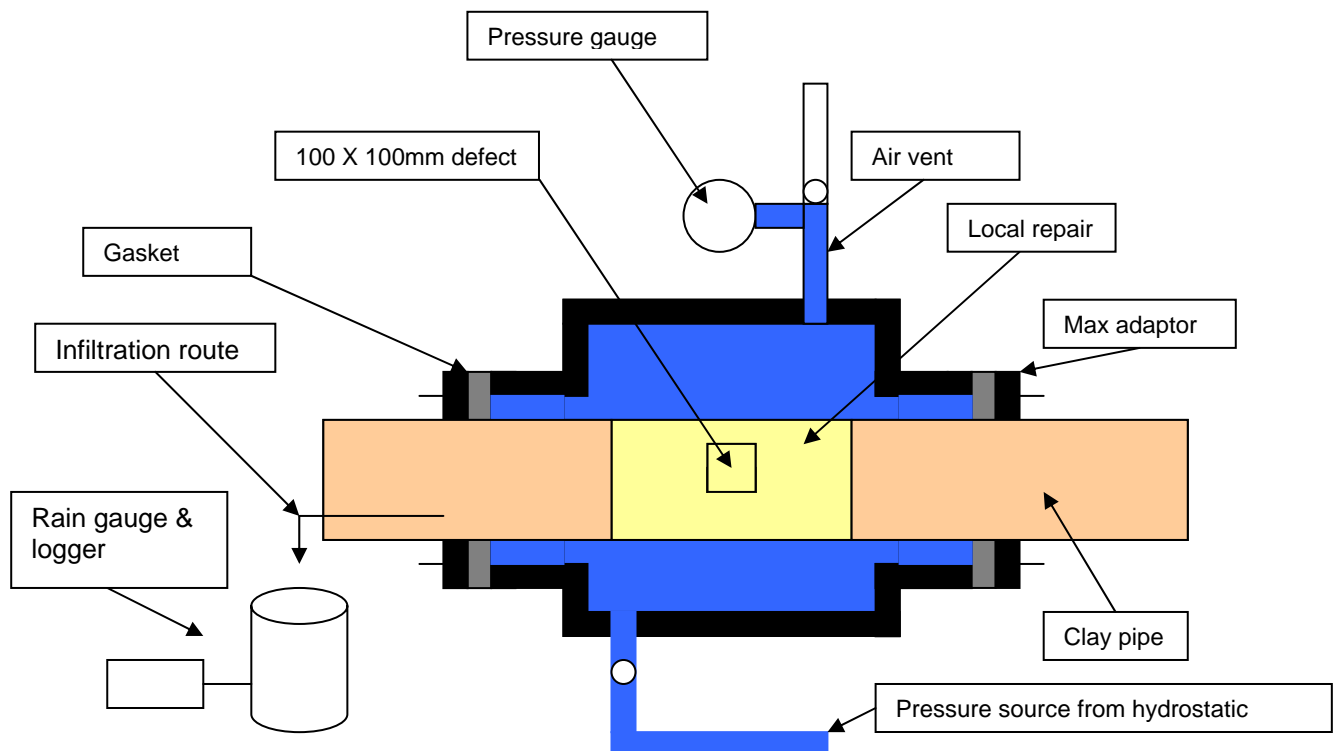
**Figure 2.1 Schematic of the localised repair pressure testing rig**

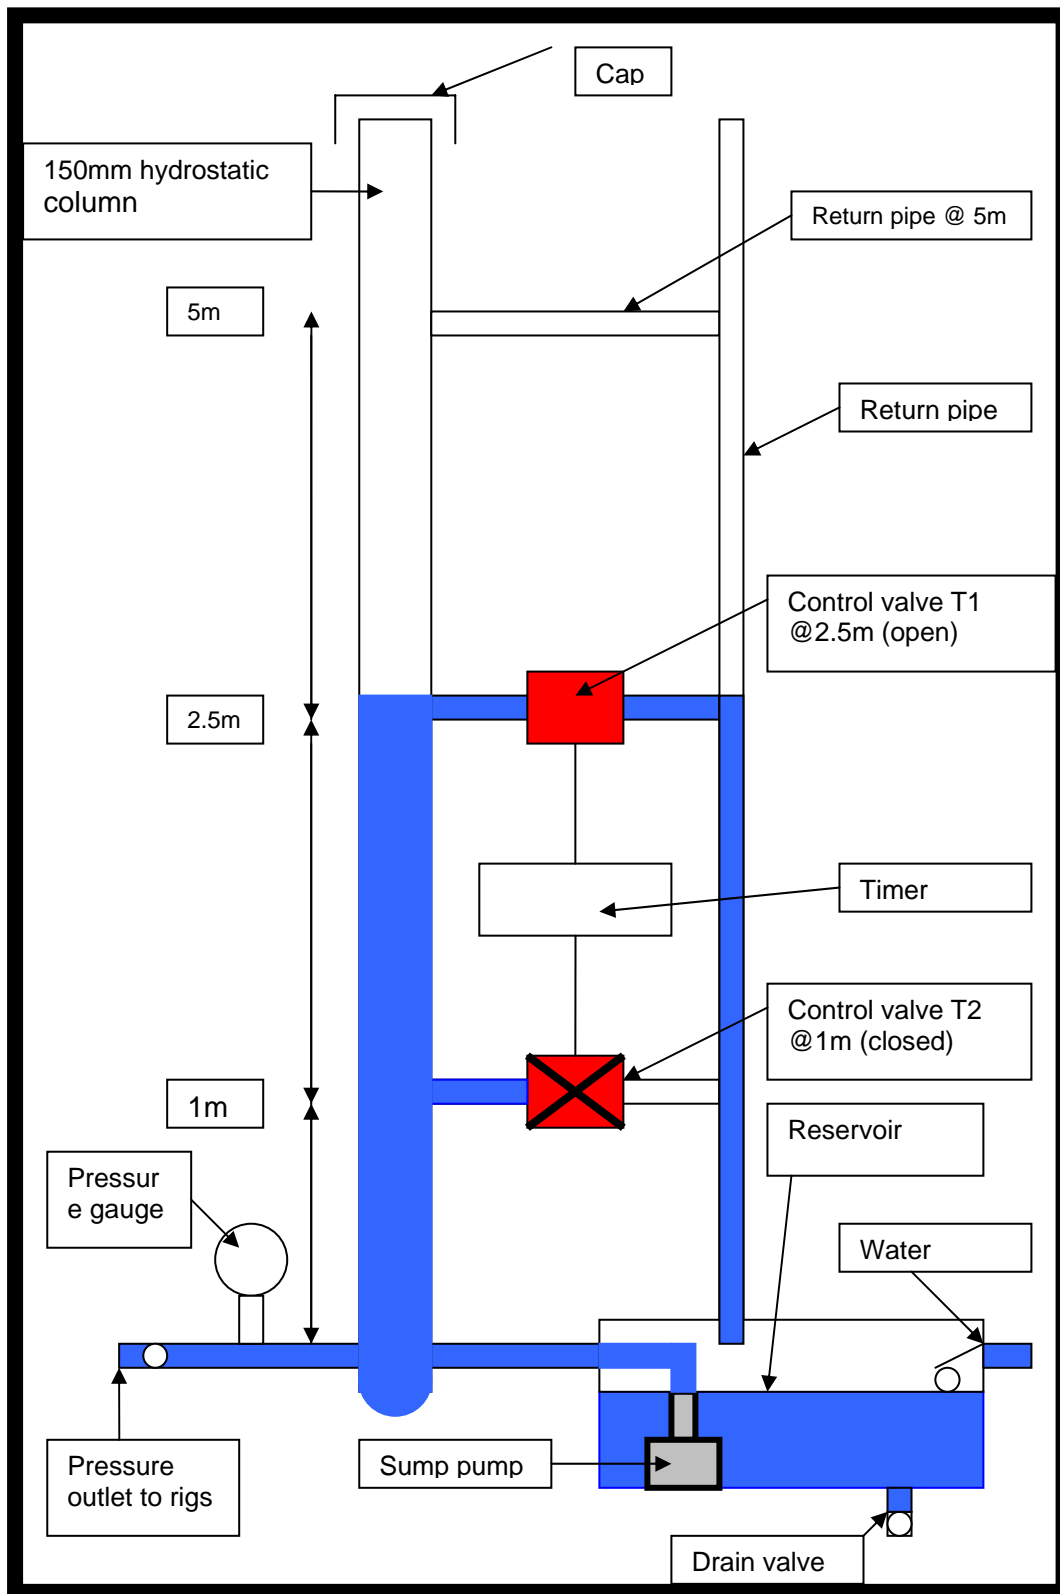
- a 1/4" (6.35 mm) connection at the bottom for the test samples, complete with isolating valve and pressure gauge.
- a 1" (25.4 mm) 'L' port valve just above the test sample connection, which is connected to the submersible pump.
- The first 1" (25.4 mm) ball valve is mounted at 1 m, the outlet of which is connected to a 1" (25.4 mm) common reservoir return pipe.
- the other 1" (25.4 mm) ball valve is mounted at 2.5 m; this is also connected to the return pipe.
- at 5 m an overflow connection is connected to the return pipe.
- the top of the 6 m column is left open to the atmosphere.
- if the first ball valve is open, the water is maintained at 1 m within the column.
- if the first ball valve is closed and the second one open, the water is maintained at 2.5 m within the column.

- if both ball valves are closed, the water is maintained at 5 m within the column.
- there is a calibrated pressure gauge at the bottom of the hydrostatic column, at a similar level to the outlet, which provides a visual readout of the water level within the column.
- the outlet has an isolation valve fitted.

Figure 2.2 Schematic of equipment providing hydrostatic test water

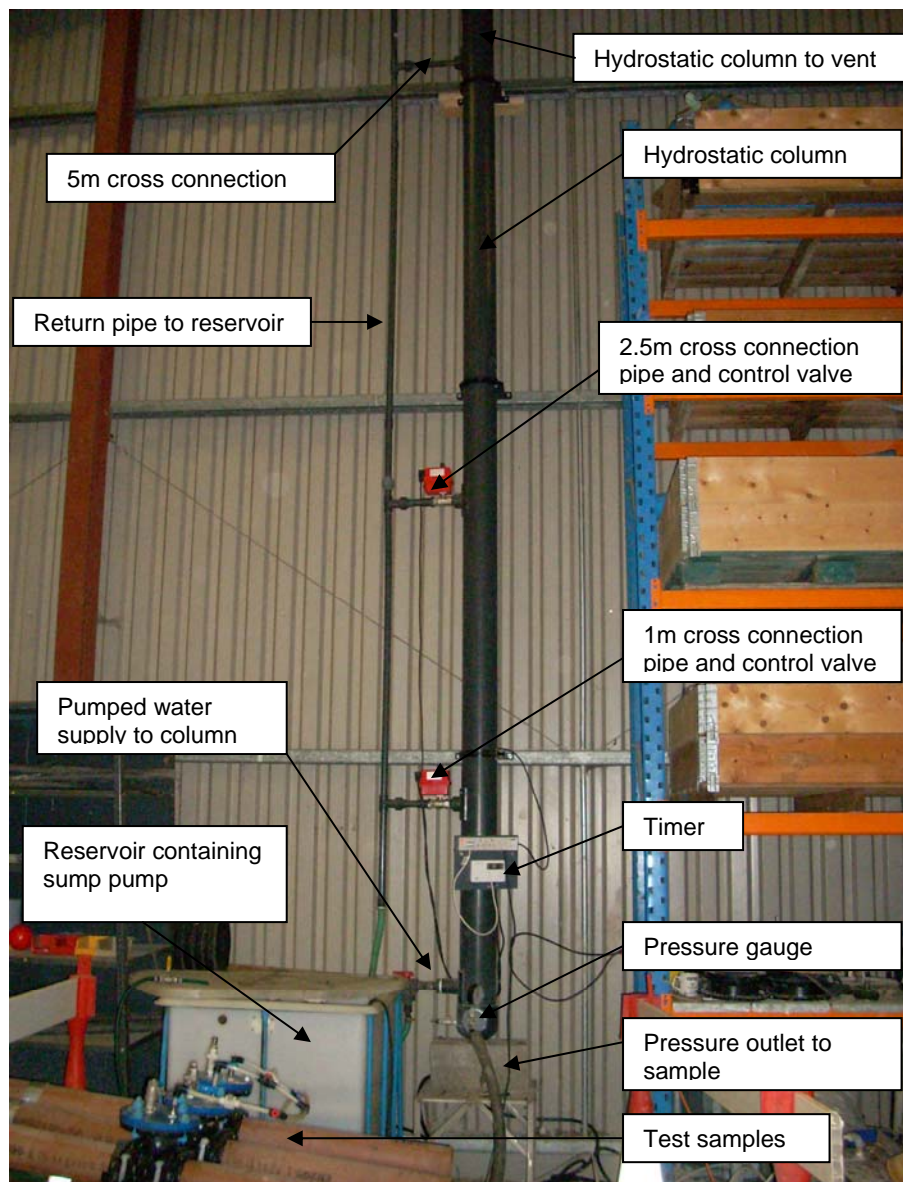
**Figure 2.3 Photograph of equipment providing hydrostatic test water**

Note: the rain gauges at the lower end of the test pieces are not shown; the test samples are not the Quick Lock test installations

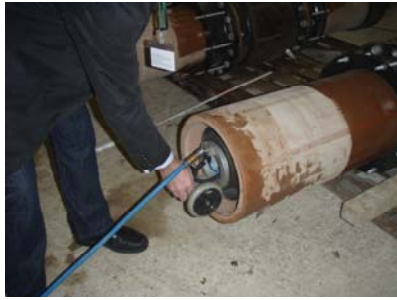
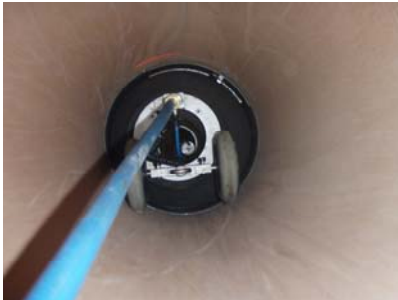
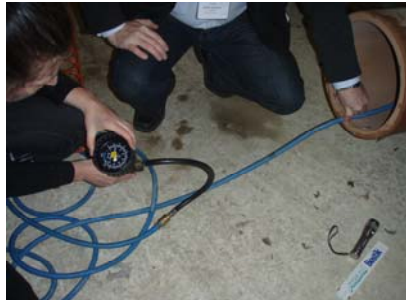
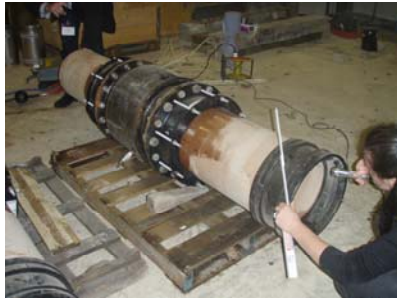
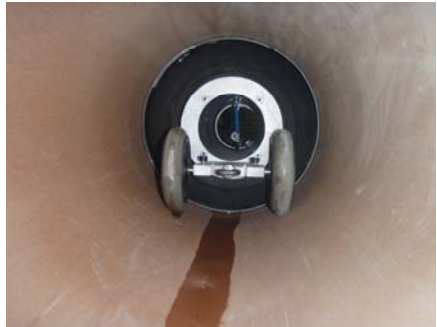
<p>1. Insertion of repair on packer</p>	<p>2. Positioning of repair over defect</p>	<p>3. Pressuring of repair to engage locking mechanism</p>

<p>4. Checking position of repair in non-pressurised installation</p>	<p>5. Infiltration before installation of Quick Lock</p>	<p>6. Sealing of infiltration when the packer is inflated and engaging locking mechanism</p>

**Figure 3.1 Installation summary**

WRc were satisfied that the installations completed for the test were representative of the product. Figures 3.1 to 3.5 show the key stages in the installation process.

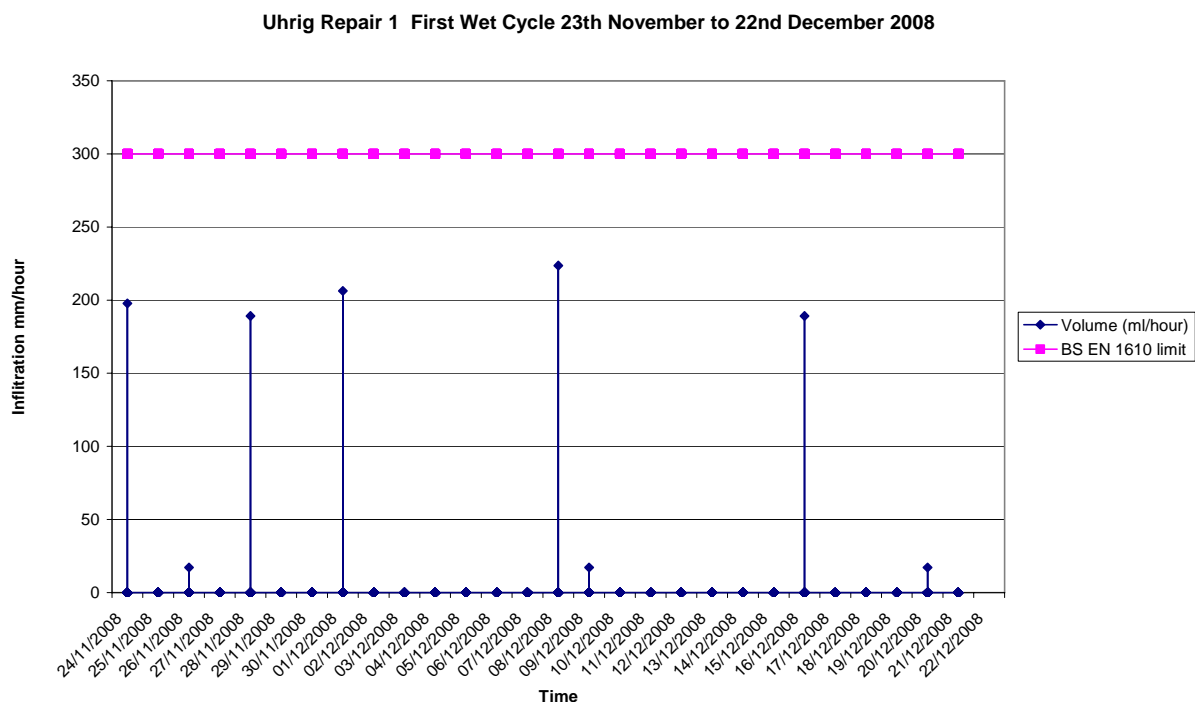
**Figure 4.1 Infiltration rate for repair 1 - first wet cycle**

For all the wet cycles, all three repairs showed no sign of any infiltration. The plots for each rig for each wet cycle can be seen in Figures 4.1 to 4.9.

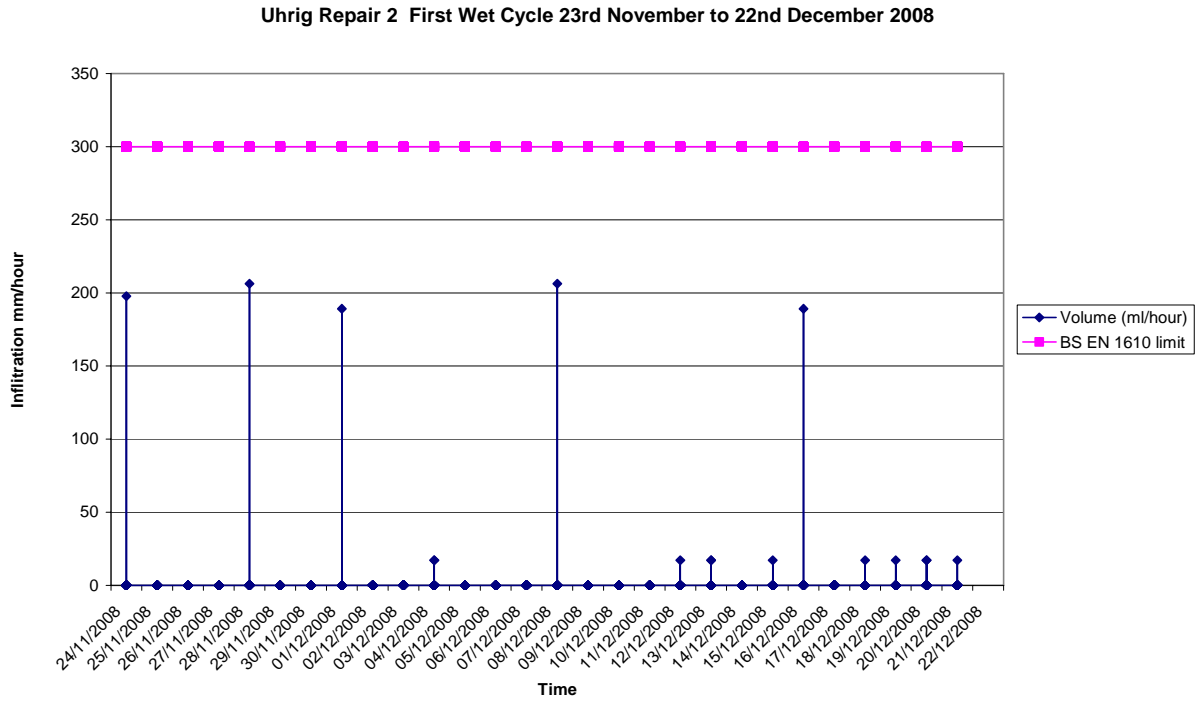
**Figure 4.2 Infiltration rate for repair 2 - first wet cycle**

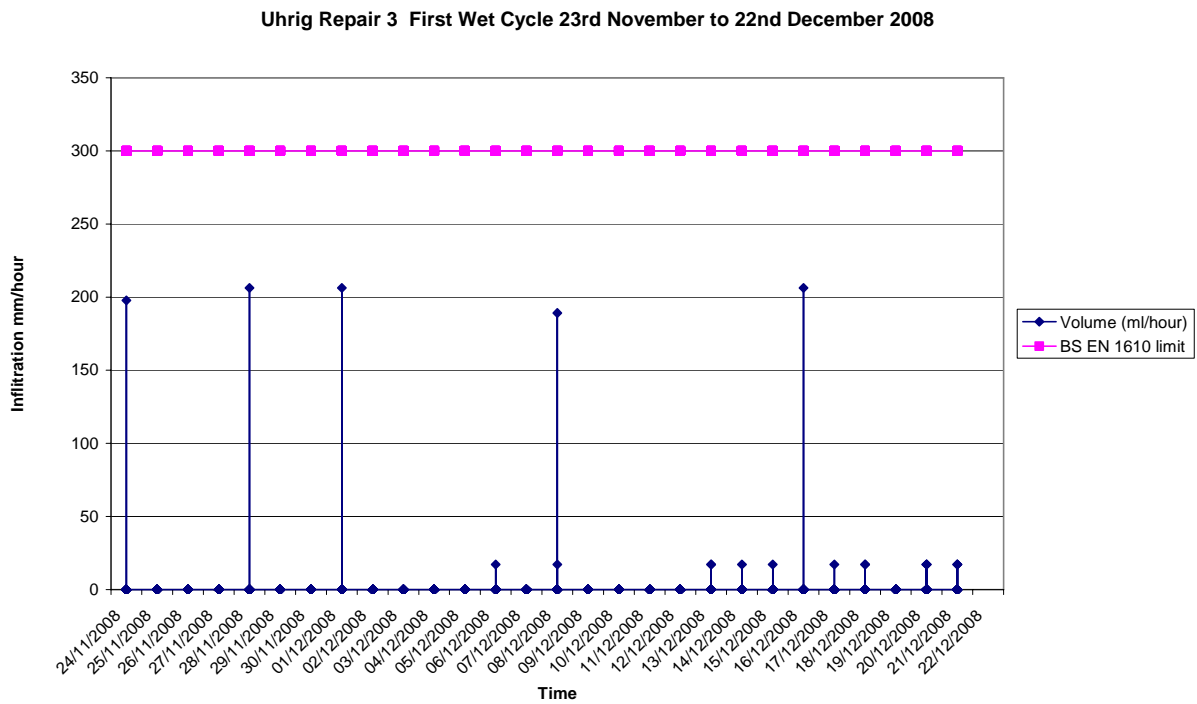
**Figure 4.3 Infiltration rate for repair 3 - first wet cycle**

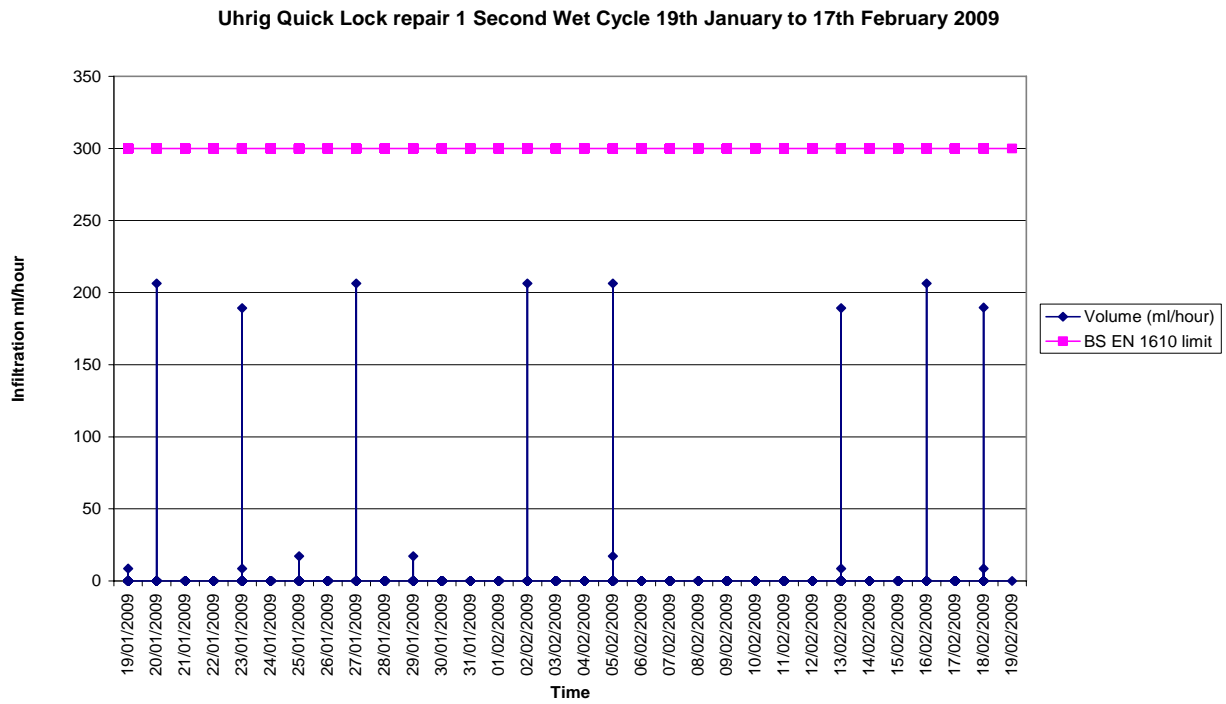
**Figure 4.4 Infiltration rate for repair 1 - second wet cycle**

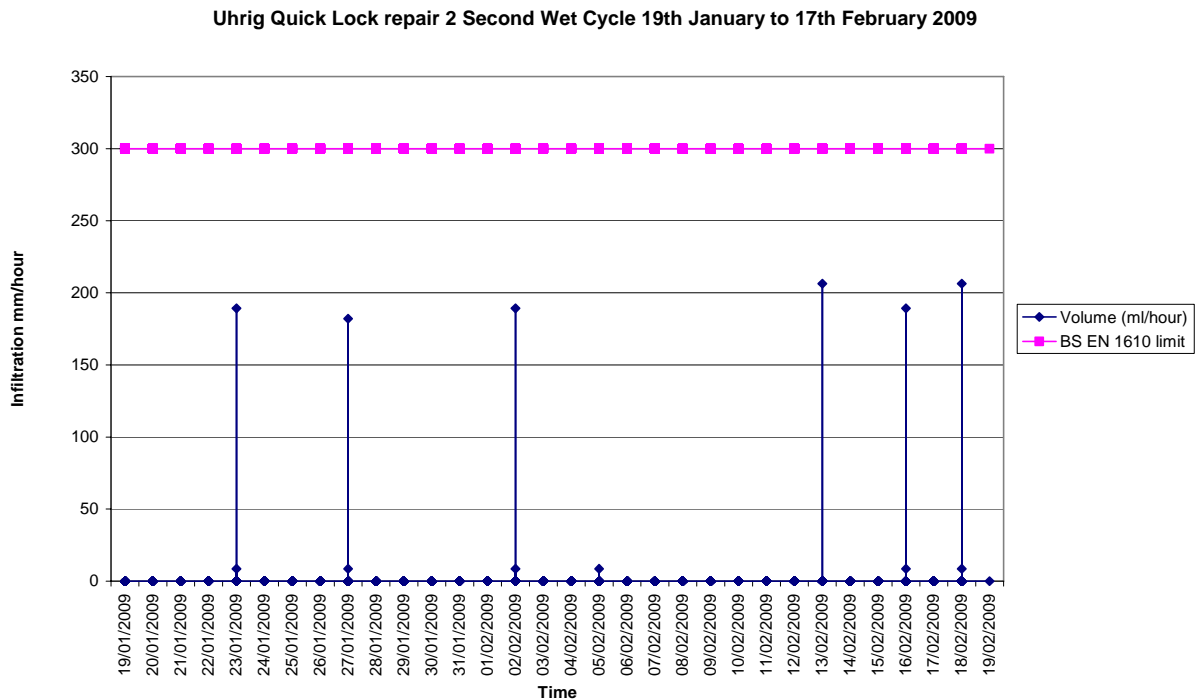
**Figure 4.5 Infiltration rate for repair 2 - second wet cycle**

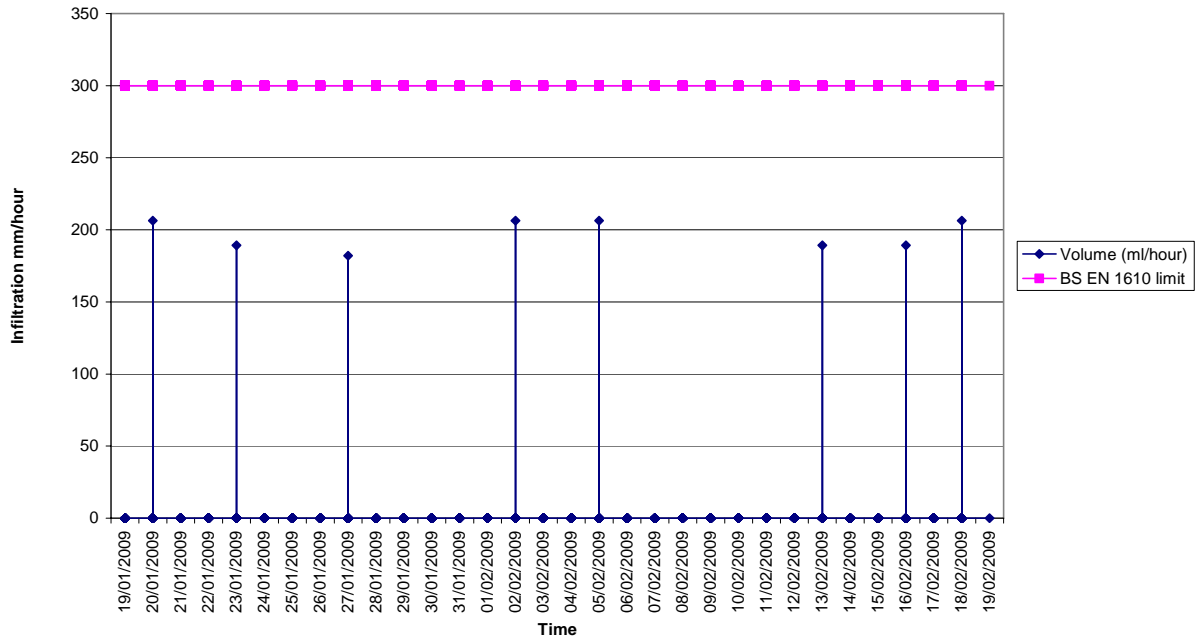
Uhrig Quick Lock repair 3 Second Wet Cycle 19th January to 17th February 2009

Figure 4.6 Infiltration rate for repair 3 - second wet cycle

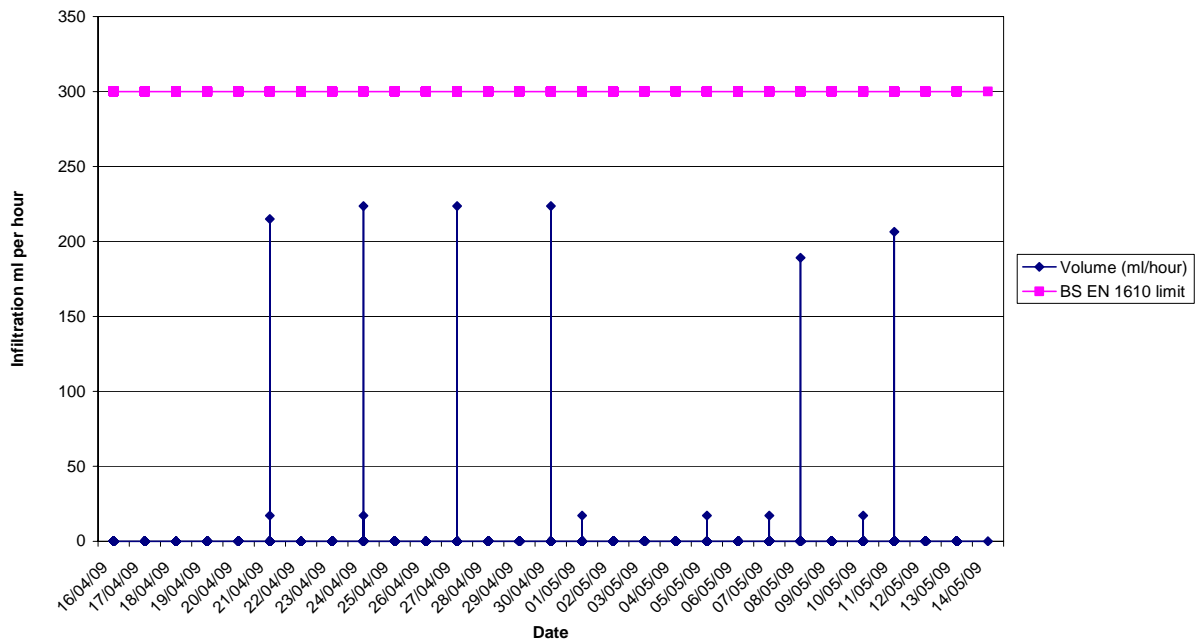
Repair 1 third wet cycle (16 April to 15 May 2009)

Figure 4.7 Infiltration rate for repair 1 - third wet cycle

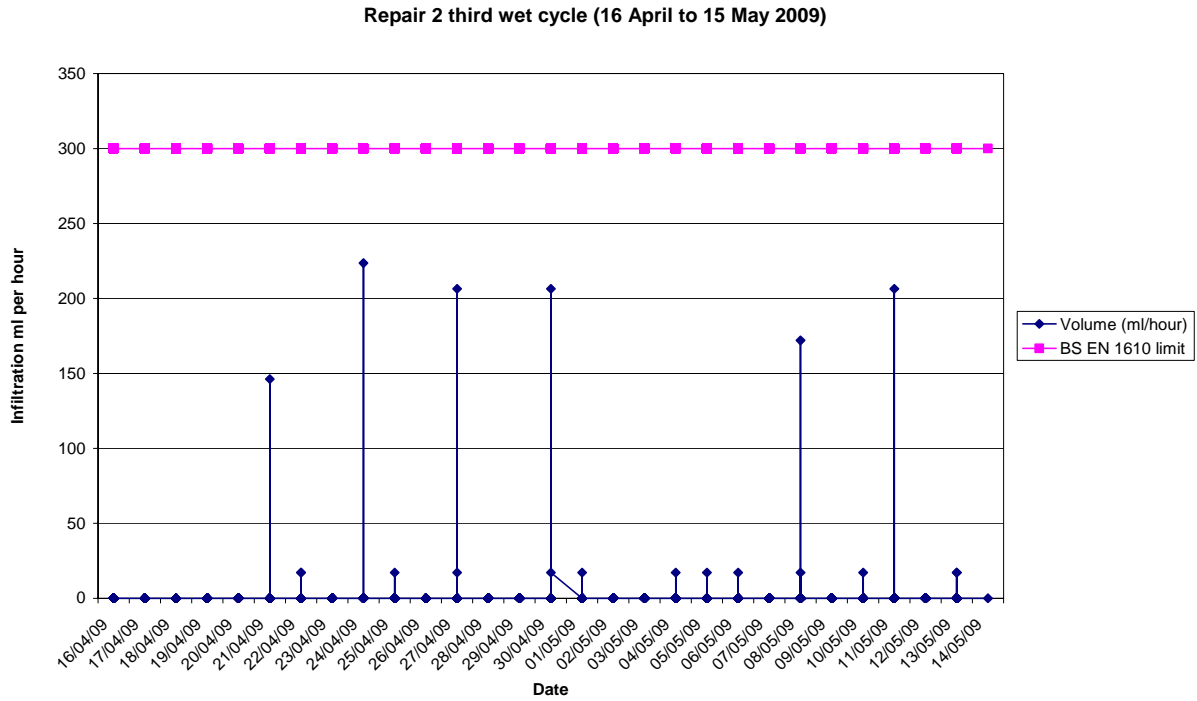
**Figure 4.8 Infiltration rate for repair 2 - third wet cycle**

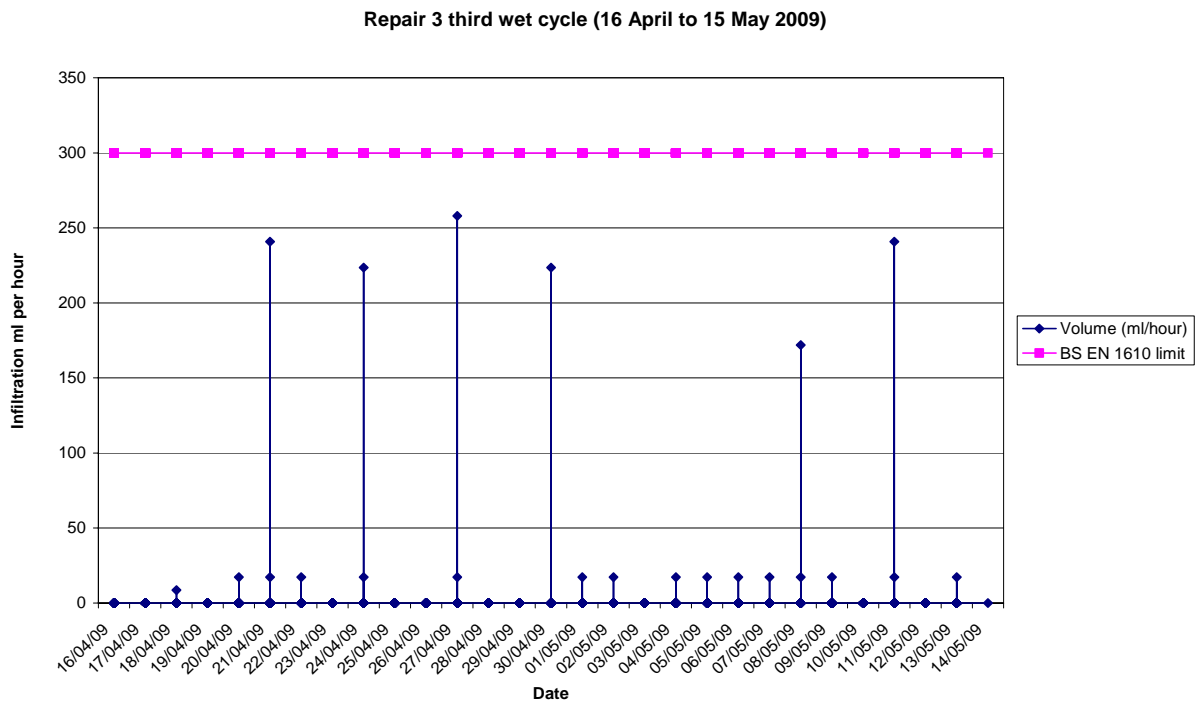
**Figure 4.9 Infiltration rate for repair 3 - third wet cycle**

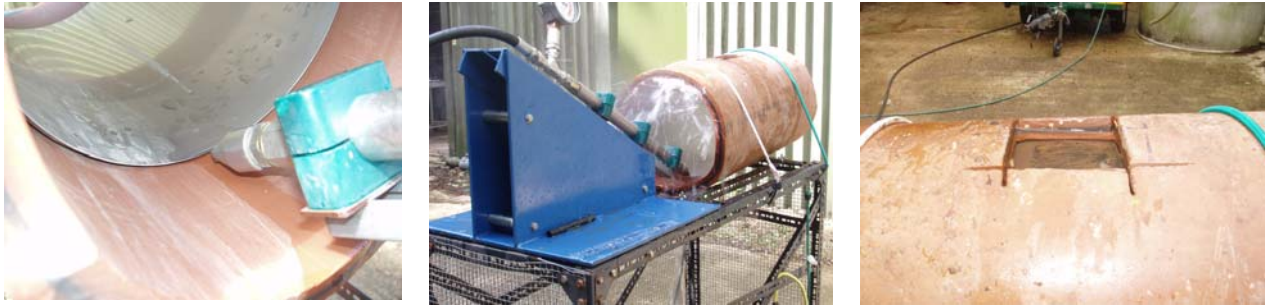
When we applied the water jet at 180 bar/2600 psi on the end of the Quick Lock sleeve where the steel is tapered to the host pipe there was no problem as the system showed no sign of water passing the seal

Figure 1 Testing of tapered end of repair

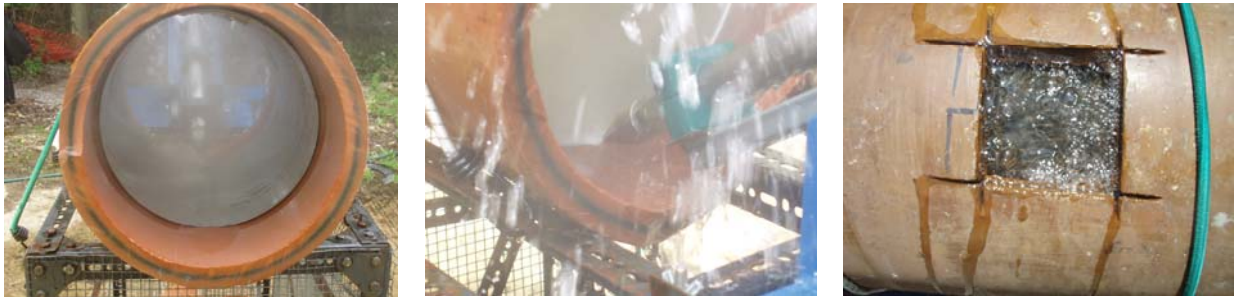
When we applied the same test to the non-tapered end we managed to push water through the seal so that it exited via the defect see photos below:

Figure 2 Testing of open end of repair
